## Washington County analyzes their AC units to save energy

**Washington County has with the help of Emerging Energy Solutions inspected fourteen roof top units on one of their building. The purpose of the analysis of these RTUs (Roof Top Units) was to establish a base line for future comparison, check efficiency, and make recommendations on maintenance, service, and optimization. The ClimaCheck Performance Analyser was used to document overall performance and behavior of the systems. The saving potential through low cost adjustments will improve the EER with 10-25% on many of the units and decrease the wear.**

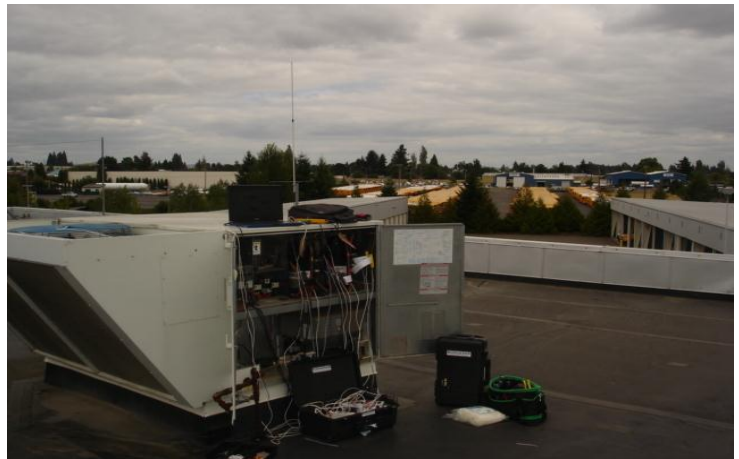
All fourteen units are manufactured by AAON. An external visual inspection show that all were in good shape. Only one compressor out of 27 has been replaced in 12 years. The facilities department who maintains them and any of the outside contractors that have done service on them have kept the system in operation without high failure rates.

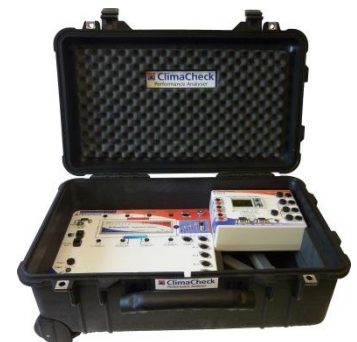
The ClimaCheck PA Pro field performance analyzer is a portable data acquisition system that uses a multitude of temperature sensors, pressure transducers, and electrical analyzing equipment, all readings and measurements are then analysed by the ClimaCheck software. The software uses thermodynamic equations and the principle of conservation of energy to calculate the same information which was before has required a research and development lab. All conclusions were made by evaluation of this data using nominal data supplied by the manufacturer. Systems for permanently installed monitoring are also available.
