CASE STUDY

Banner Health Ironwood Medical Center

CHILLERS OPERATE BEST WITH HELP FROM ClimaCheck!

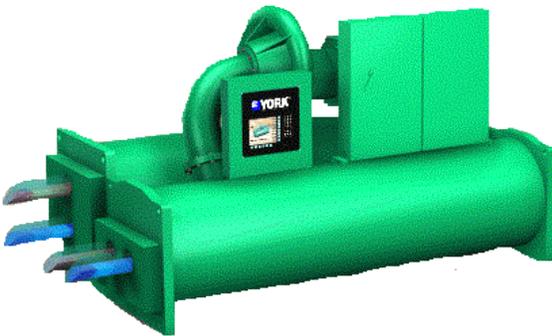
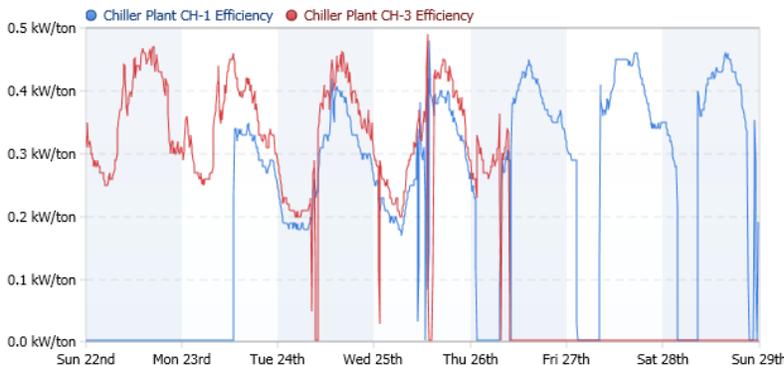
In early April, Chiller 1 was 10-15% less efficient than Chiller 3. It was found that the culprit of this discrepancy was low refrigerant. By adding 550 lbs of refrigerant, Chiller 1 performed 15% better than Chiller 3 as observed both by chiller efficiency and refrigerant temperatures. Similarly, ClimaCheck detected a refrigerant leak in Chiller 3. The leak was repaired and 350 lbs of refrigerant was added.

ClimaCheck identified issues with Chiller 2 – its efficiency went from being better than the two other chillers to worse as the loads changed. The IGV actuator had failed, preventing the chiller VFD from modulating properly.

After the IGV actuator was replaced, Chiller 2 was able to maintain chilled water temperature setpoint and saw an improved efficiency.
